CONDITION SURVEY, LAGUNA ARMY AIRFIELD YUMA PROVING GROUND, ARIZONA

P. J. Vedros, R. D. Jackson, S. J. Alford

June 1973

Conducted by U. S. Army Engineer Waterways Experiment Station
Soils and Pavements Laboratory
Vicksburg, Mississippi

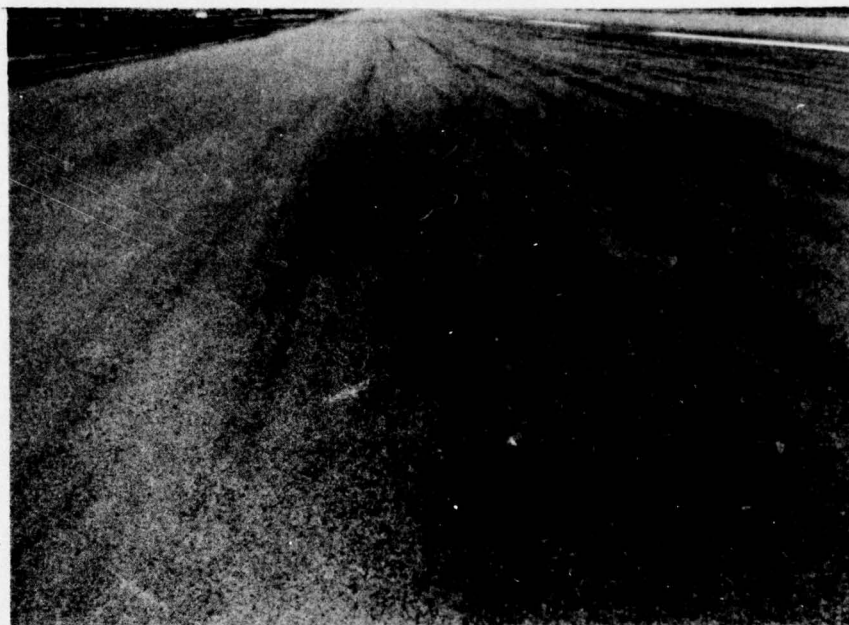
Photo 1. Cracking in longitudinal construction
joint on N-S runway

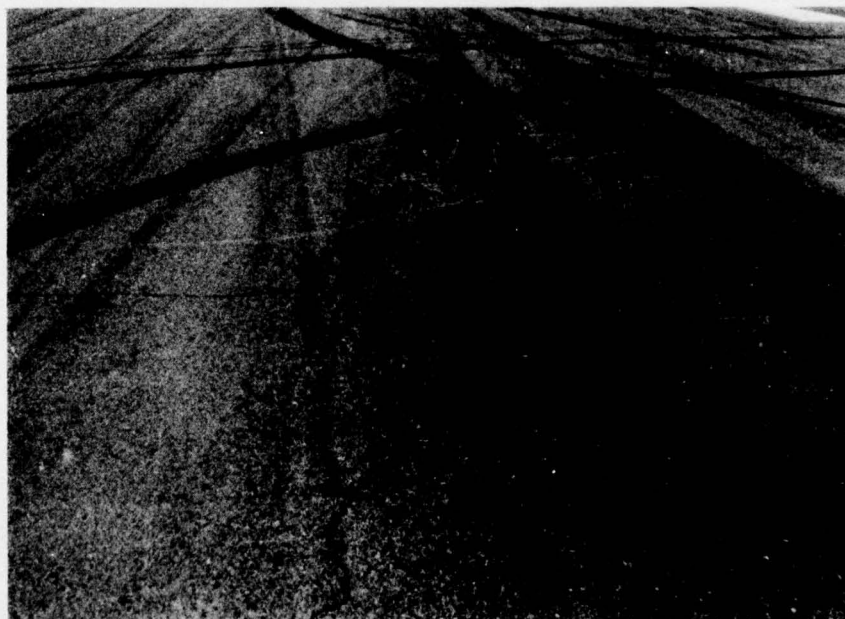
Photo 2. Reflection cracking in surface
on N-S runway

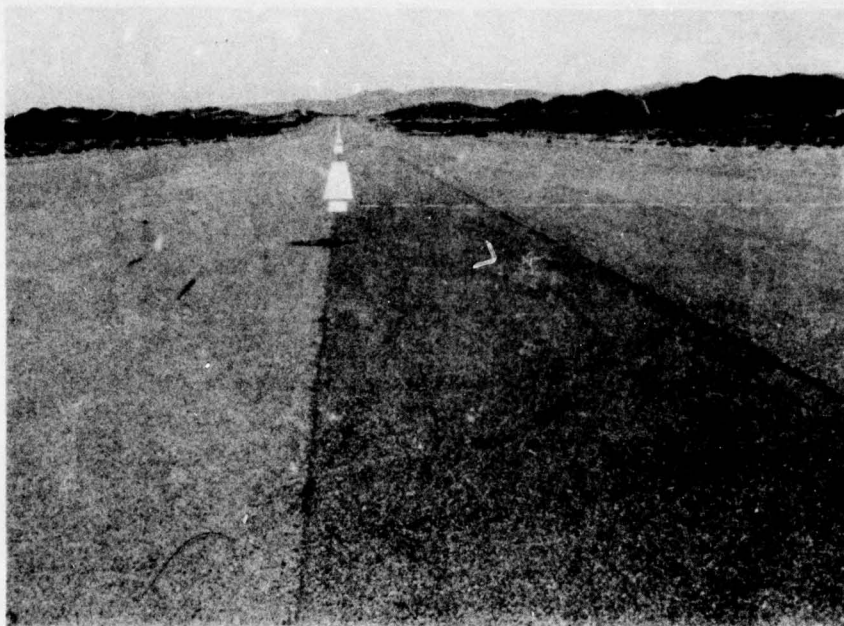
Photo 3. General view of E-W runway

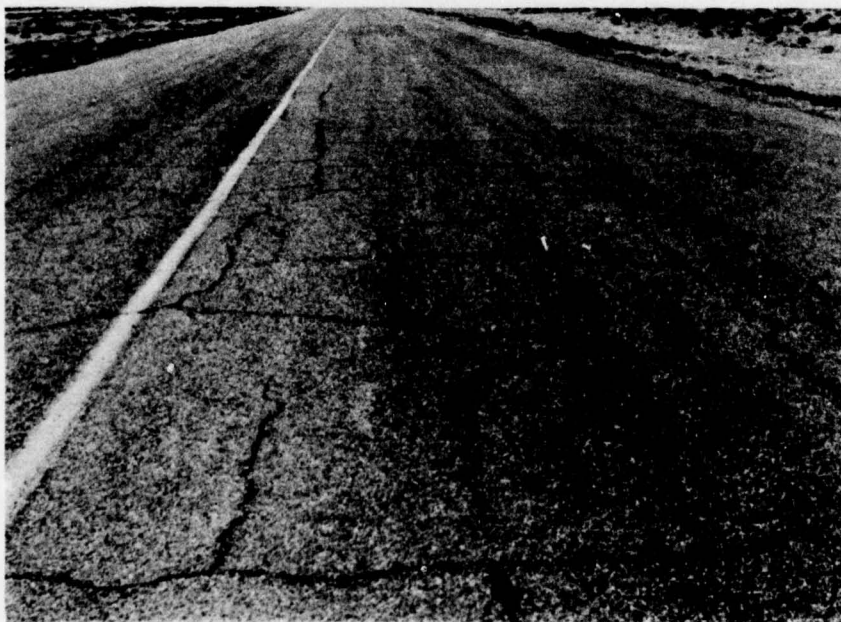
18. The load-carrying capacities of the pavements at LAAF are presented in table 5. As is noted in this table, the basic field evaluation for the primary pavements is controlled by the carrying capacity of the north end of the N-S taxiway (feature T2B). The surface condition of this feature was poor. Occasional use of the pavement facilities by aircraft having gross weights greater than those allowable under the basic evaluation may be necessary. Table 6 shows the allowable loading of such aircraft operating at frequencies of one cycle per day, one cycle per week, and one cycle per month. The evaluation presented in table 6 applies only to the ability of the pavement to withstand a load. It is beyond the scope of this evaluation to determine the capability of the airfield to handle aircraft from the standpoint of the length of runway required, etc.

Photo 4. Surface condition of N-S taxiway (feature T2B).
Area has not been overlaid

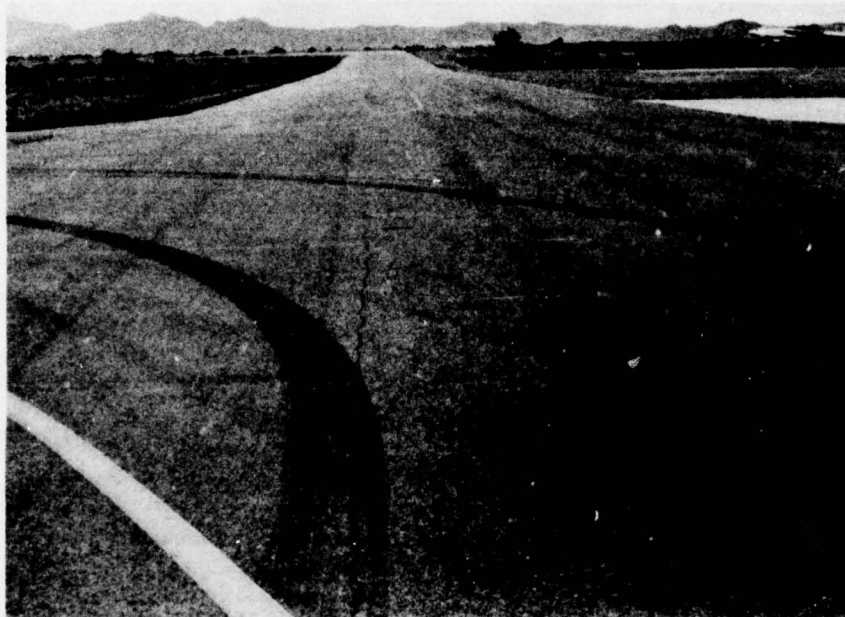
Photo 5. Surface condition of N-S taxiway (feature T3B).
Overlay was placed in 1971
